METHOD FOR GLOBAL AND LOCAL LEAK DETECTION APPLICATION FOR HYDRAZINE PROPULSION SYSTEMS

Abstract. *The China-Brazil Earth Resources Satellite (CBERS-FM2) was designed to be three axes stabilized, in other words, an inertial stabilized satellite. As part of the qualification tests, the spacecraft hydrazine propulsion system had to be completely checked against any possible significant leakage which would dangerously reduce its operational lifetime while in orbit. These tests included the Local Leak Tests, where each part of the propulsion system was individually leak tested using Helium Leak Detectors, and the Global Leak Tests, where the whole spacecraft Service Module (SM) was installed in a Space Simulation Chamber, a large thermal vacuum system, where an external Helium Leak Detector was attached for leakage rate measurements. This paper describes the development of the employed methodologies and does an analysis of the obtained results.*

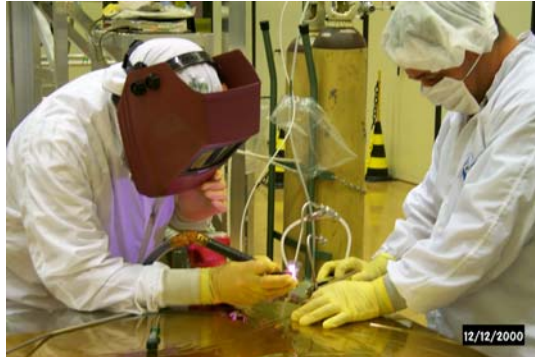
Figure 1. Titanium pipeline welding process

installed at their proper operational locations, the dia. 6mm x 1mm thickness titanium pipeline had to be curved and bent in angles to follow the routing through the spacecraft internal geometry. Inter-connections and valves are also required for the firing procedures. Some pictures of part of the CBERS FM2 propulsion system are shown in fig. 1, 2 and 3.

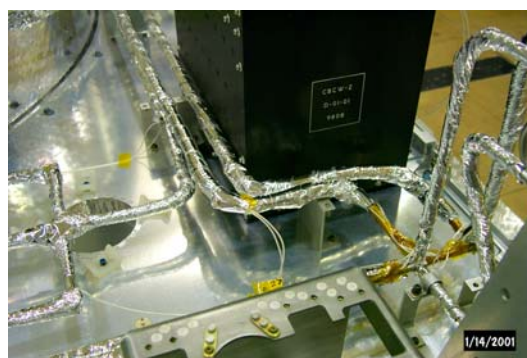
Figure 3. Pipeline covered by Multi Layer Insulation

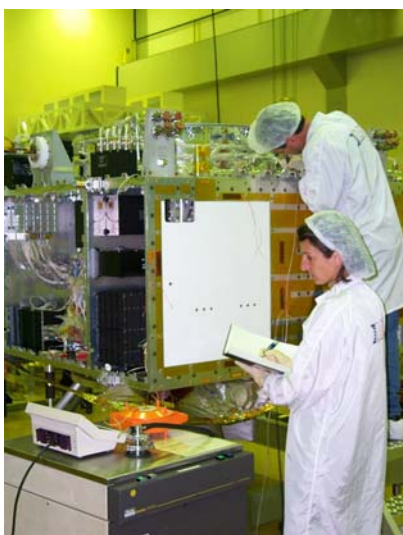
Figure 4. Local Leak Tests - INPE

In order to get the most of any possible leak, small plastic bags were placed around each one of the selected spot to be leak tested. These were done to ensure a separate atmosphere from the external environment. At the end of the sniffer probe, a sharp needle could then cut a small hole in the plastic and, for at least 10 seconds, to check for the leak tightness of that particular spot. A picture showing this operation can be seen in Fig. 4.

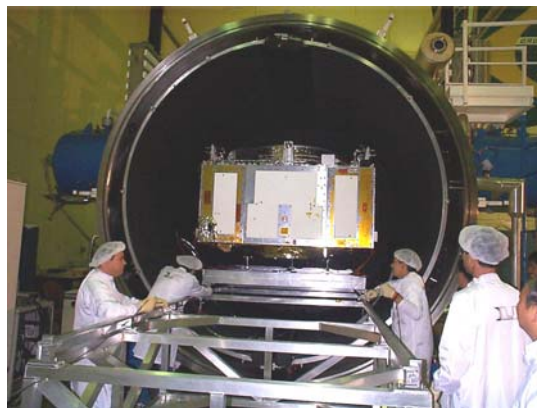
Figure 5. Preparation for *Global Leak Tests* - INPE

In the sequence, it was performed the *Global Leak Tests* of the CBERS FM2 spacecraft. For this, it was also required its propulsion system to be pressurized with 99.999% high grade Helium to 2MPa. Following the planned sequence, the whole Service Module was installed in LIT 3m dia. x 3m long Space Simulation Chamber. This chamber was built using 304L Stainless Steel and, to get its high vacuum conditioning, it is equipped with two 35" 25,000 l/s (blue painted) cryopumps. A picture of this test set up is presented in Fig. 5. At one of the vacuum ports of this thermal vacuum chamber the Helium Leak Detector was connected, valve closed (see Fig. 6).

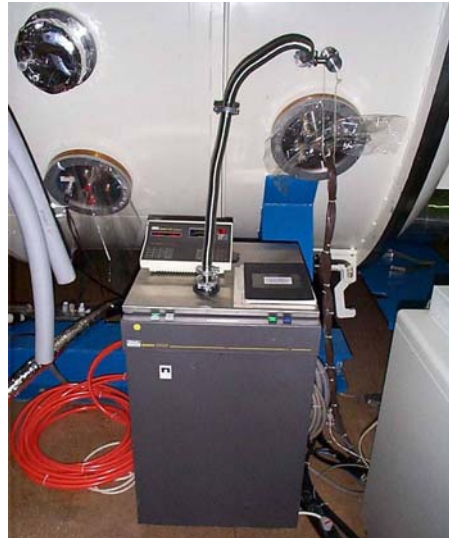
Figure 6. Leak Detector connected to TVC port

The Leak Detector to Thermal Vacuum Chamber connection port valve was carefully opened and the rate of leak coming from the entire pressurized spacecraft propulsion system could be measured. A total of five distinct measurements were taken, during an elapsed time of approximately 50 minutes (Garcia, 2001). The results are presented in Tab. 5.

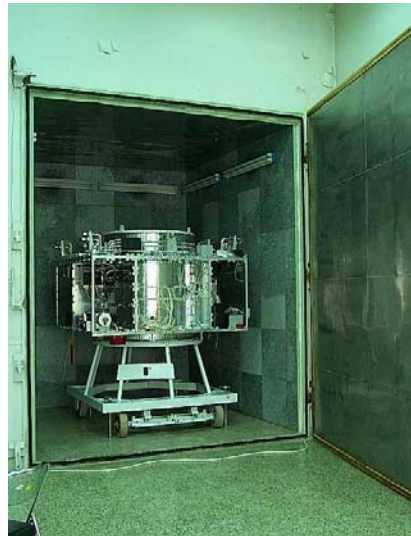
Figure 7. CBERS FM2 in Atmospheric Chamber for the *Global Leak Tests* procedures - China

That Chinese rectangular shaped Chamber had metallic door and granite walls. The hinged door was sealed to the Chamber frame by using rubber and foam compression strips. A blower, installed on the left wall of the Chamber, was used to increase the uniformity of the gaseous environment prior to each sample reading. Rubber hoses protruding into the Chamber, also from the left wall and located approx. 1m from the floor, were used to collect and replace the sample to perform the concentration analysis. A Mass Spectrometer, coupled to a HP 34401A Multimeter to get the output readings, was used to measure the mass 4 concentration of the Helium gas. A large control panel, containing valves and analog pressure and flow gauges was used to set and to control the parameters of the flow to the Chamber. A two-way selecting valve was used to alternate from a standard He sample (99.999%) to the flow coming from the Chamber. A small pump was used to produce the gas flow in a close circuit from the Chamber through the Mass Spectrometer analyzer.

A picture showing the CBERS FM2 spacecraft installed inside the Chinese atmospheric pressure chamber can be seen in Fig. 7.
